**Town of Grafton  
Self-Evaluation and Transition Plan  
June 2019**

# **TOWN OF GRAFTON – SELF-EVALUATION AND TRANSITION PLAN**

## VII. ADA TRANSITION PLAN

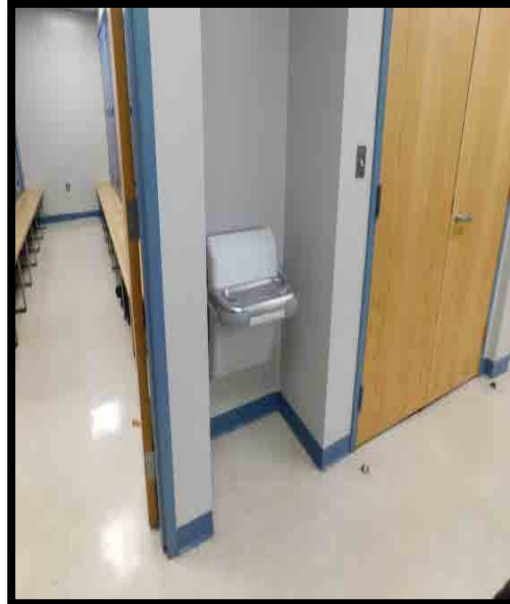
Photo Police 6

<b><u>Drinking Fountain (Basement Level)</u></b> The drinking fountain is non-compliant as it is not a "hi-low" fountain.  See Photo Police 6.	211	36.1.1	Option #1 – Discontinue use of the existing drinking fountain.  Option #2 – remove the existing drinking fountain and replace with a "hi-low" drinking fountain. The drinking fountain must comply as follows:  Protruding objects compliance of no > 4" protrusion between 27" and 80" a.f.f. (307); 30"x48" clear space requirement (305), and knee/toe clearance (306). Knee clearance is 9" to 27" a.f.f; 25" deep max. at 9" a.f.f. or 11" deep min at 9" a.f.f. and 8" deep min at 27" a.f.f. Width of knee clearance s/b 30" wide min (306.3). Toe clearance as part of c.f.s. 17" min – 25" max, 9" high a.f.f., 30" wide (306.2). The spout s/b 15" min from wall and 5" max from the front edge of the unit (602.5). Flow of water 4" high min and spout located max 5" from front (602.6). The spout height s/b 36" max. a.f.f. for "low" and 38" min a.f.f. to 43" max a.f.f. for "high". The controls s/b operable w/one fist; no > 5 lbs force (309.4).	4	3	N	\$0 to \$2,500

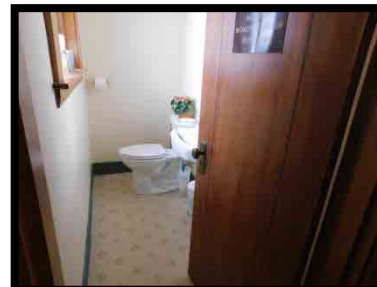
Photo Historic 4

<b>Bathroom</b> The bathroom is wholly non-complaint with inadequate clearances for wheelchair maneuverability and no accessible components (grab bars, signage, door hardware, compliant heights, etc.). <a href="#">See Photo Historic 4.</a>	603 604 606	30	Discontinue use as a bathroom or modify/construct a space elsewhere to include a bathroom to meet 2010 ADA Standards and 521 CMR Standards for a single user accessible toilet room. Modification will require either partitioning of existing space or the construction of an addition to the rear of the building.	3	4	L	\$50,000 to \$150k+

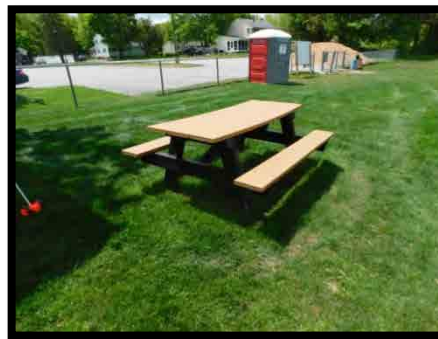
Photo Airport Park 6

The existing picnic table does not provide the required accessible knee and toe clearance. <b>See Photo Airport Park 6.</b>	226.1 902	19.5.2 19.6.2	At least 5% or at least one table must be accessible. Replace the existing table or provide an additional one which has a table surface of between 28" to 34" a.f.f. to the top surface with at least 27" knee clearance, 30" clear width, and 19" depth.	2	1	N	\$750
The bleachers lack level surface areas for wheelchairs.	221.2 802.1	14 19	Create an approach and wheelchair companion area at the bleachers. Spaces should be 36" wide x 60" deep per wheelchair. If paired, spaces can be reduced to 33" in width. If a front/rear approach, the depth can be reduced to 48" as opposed to 60" for a side approach.	2	3	N	\$700

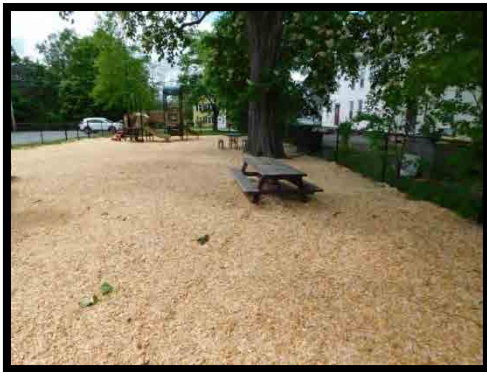
Photo Norcross Park 9

The playground picnic tables do not provide the required accessible knee and toe clearance. <b>See Photo Norcross Park 9.</b>	226.1 902	19.5.2 19.6.2	At least 5% or at least one table must be accessible. Replace one picnic table or provide an additional one which has a table surface of between 28" to 34" a.f.f. to the top surface with at least 27" knee clearance, 30" clear width, and 19" depth and on an accessible route.	2	1	N	\$750
<u>Men's and Women's Bathrooms</u> The entry doors accessible tactile designation signage is mounted too high and is not on the latch side of the door.	703	41.1	Install accessible compliant designation on the latch side of the doors with appropriate finish and contrast and character height and proportions, raised and brailled characters should also be included. Tactile characters on the sign s/b 48" min. a.f.f.. from baseline of lowest character and 60" max. a.f.f. to baseline of highest character. Characters must meet the ADA Standards for character height, finish and contrast, accompanied by Grade 2 Braille (703 ADA Standards). Install lever hardware on the interior door.	3	2	I	\$125

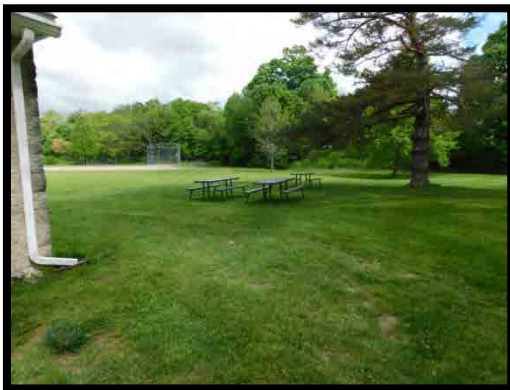
Photo Nelson Park 3

None of the picnic tables (3 scattered, 3 at concessions area) do not provide the required accessible knee and toe clearance and are not on an accessible route. See Photo Nelson Park 3.	226.1 902	19.5.2 19.6.2	At least 5% or at least one table must be accessible. Replace one picnic table or provide an additional one which has a table surface of between 28" to 34" a.f.f. to the top surface with at least 27" knee clearance, 30" clear width, and 19" depth and on an accessible route. At least one accessible table s/b located at the concession area and one scattered site.	2	1	N	\$1,500
No accessible route exists to the basketball court, ball fields, player benches, bleachers, and to the playground. Five of the six ball field player benches have an abrupt change in level surface of nearly to 2". See Photos Nelson Park 4, 5, and 6.	402 303 403.3 403.4 802.1 221.2	19.0 20.0 22.4 14 19	Construct an accessible route to the basketball court, ball fields, player benches, bleachers, and playground compliant with width and slope (2% cross, 5% running) requirements and abrupt change in level surface requirements (no greater than ¼" unbeveled). Create an approach and wheelchair companion area at the bleachers. Spaces should be 36" wide x 60" deep per wheelchair. If paired, spaces can be reduced to 33" in width. If a front/rear approach, the depth can be reduced to 48" as opposed to 60" for a side approach.	1	3	L	Up to \$34,000+

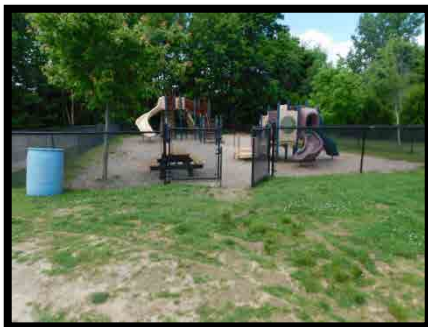
Photo Riverview 3

The existing picnic table does not provide the required accessible knee and toe clearance. See <a href="#">Photo Riverview 3</a> .	226.1 902	19.5.2 19.6.2	At least 5% or at least one table must be accessible. Replace the existing table or provide an additional one which has a table surface of between 28" to 34" a.f.f. to the top surface with at least 27" knee clearance, 30" clear width, and 19" depth.	2	1	N	\$750
There is no level surface area for wheelchairs at the playground bench.	221.2 802.1	14 19	Create an approach and wheelchair companion area at the bench. The space should be 36" wide x 60" deep per wheelchair. If a front/rear approach, the depth can be reduced to 48" as opposed to 60" for a side approach.	2	3	N	Included in above
No accessible route exists within the playground area to the two play structures, bench, and picnic table. No accessible route exists around the perimeter of the play area. There are no accessible play components. Non-compliant wood mulch is the sole surface treatment for the play area. See <a href="#">Photo Riverview 4</a> .	402 1008.2 226.1	19.7 20.0 14 19	Construct an accessible route compliant with width and slope (2% cross, 5% running) requirements around the perimeter of the play area (4' wide minimum) and to the play structure elements (stairs, slide base, etc). A minimum of 32" clear width must exist at the gated entrance. The accessible route must be stable, firm, and slip resistant. Construction options include compacted stone dust, asphalt, concrete, poured in place products, etc. Costs will vary depending on product used. Accessible playscape and ground components should be added. The bench and picnic table s/b located on an accessible route. The bench should have a wheelchair companion area (see above). Play area ground surfaces must comply with ASTM F 1951 and ASTM F 1292.	1	3	L	Up to \$30,000

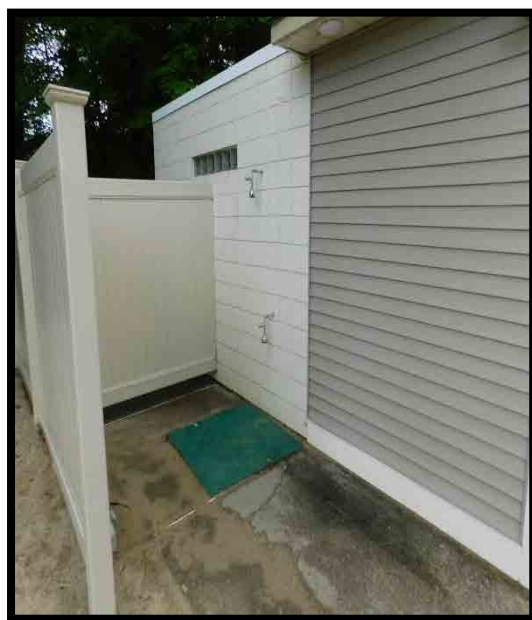
Photo Silver Lake 8

The shower pulls are not within reach range at 55" to 56" a.f.f. and cannot be used with a closed fist due to the size of the pull ring. <a href="#">See Photo Silver Lake 8.</a>	308.2 308.3 309	6.5 6.6 39	Lower the bottom of pull device to no more than 48" a.f.f. and replace the existing ring with a larger one that can be operated with a closed fist.	3	2	I	\$100
<u>Men's and Women's Bathrooms</u> The entry doors lack tactile accessible designation signage on the latch side of the door.	703	41.1	Install accessible compliant designation on the latch side of the doors with appropriate finish and contrast and character height and proportions, raised and brailled characters should also be included. Tactile characters on the sign s/b 48" min. a.f.f. from baseline of lowest character and 60" max. a.f.f. to baseline of highest character. Characters must meet the ADA Standards for character height, finish and contrast, accompanied by Grade 2 Braille (703 ADA Standards).	3	2	I	\$70

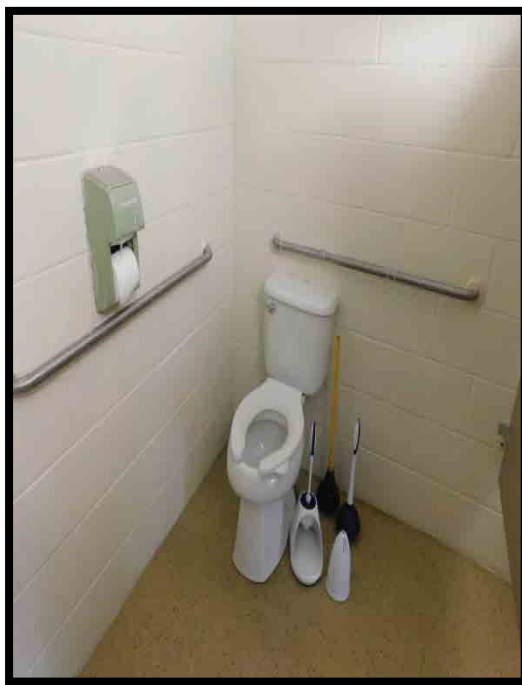
Photo Silver Lake 10

The men's and women's stall door coat hooks are 17" too high.	308.2 308.3	30.6.1	Lower coat hook to no more than 48" a.f.f.	3	2	I	\$0
The women's water closet flush control is not on the open or wide side. <b>See Photo Silver Lake 10.</b>	604.6	30.7.5	Relocate flush control so that it is on the wide or approach side or replace with an automatic flush control. Wrap and/or insulate piping.	3	3	I	Up to \$750
The men's water closet is 1¼" too close to the near wall; the women's water closet is 1½" too far from the near wall.	604.2	30.7.2	Modify the existing water closets such that the centerline of the water closets are 18" from the nearest sidewall and at least 42" from the farthest sidewall or object.	3	3	N	Up to \$1,500

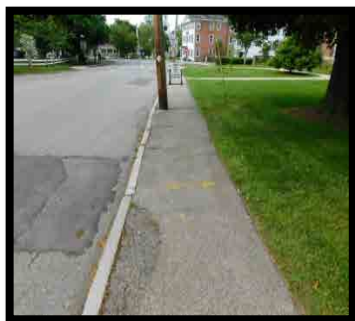
Photo Town Common Sidewalk 1

Overall, the sidewalks within and around the Town Common are in fair to good condition with some exceptions. Sidewalk clear width requirements are met, however a number of street intersections involve non-compliant curb ramps and/or crosswalks (described below). The sidewalks in front of the library which have some abrupt changes in level surface of  $> \frac{1}{4}$ " and show evidence of deterioration and heaving, the other sidewalks meet minimum accessibility standards. The "walkway" to the monument at the South Street/Upton Street intersection is non-compliant due to the use of loose stone. Approximately 4 concrete pads (roughly 20') immediately adjacent to the Worcester Street curb ramp at the Town House has cross slopes that vary from 2.5% to 5.7%. At the time of the site visit, a library sign restricted sidewalk access on South Street. **See Photos Town Common Sidewalks 1, 2, and 3.**

Depending on construction means (asphalt vs. concrete) and methods, costs could vary from \$10,000 to \$20,000.

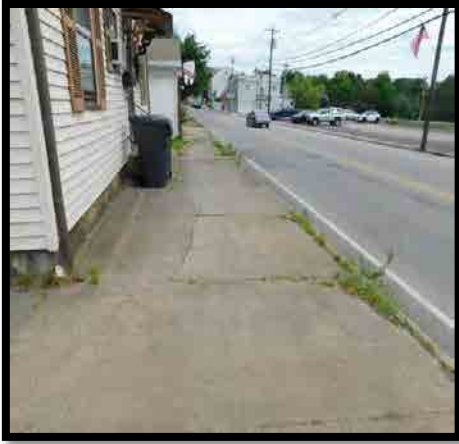
Photo N. Main St. Sidewalk 1

Overall, with the exception of the concrete sidewalks on the east side of North Main Street (Erickson's Hardware), the remaining asphalt and concrete sidewalks are in poor to very poor condition. The concrete sidewalks in the #31 to #41 North Main Street area are severely deteriorated with cracks, loss of concrete, heaving, and numerous abrupt changes in level surface of  $> \frac{1}{4}$ ". A number of the driveway cross slopes vary to as much as 16.6% (maximum 2.0% allowed). A manhole cover and related surface deterioration at #41 North Main Street creates further impediments to travel. Similarly, debris accumulation (sand, leaves, dirt) in sidewalk areas further restricts access. The asphalt sidewalk at Ray Street is similarly cracked, heaved, and has an unlevel surface. [See Photos North Main Street Sidewalks 1, 2, 3, 4, 5, and 6.](#)

At a minimum, noncompliant sidewalks on the west side of North Main Street should be replaced. The transition area to driveways need to maintain a no more than 2.0% cross slope and as a result, may require temporary construction easements on private property to modify driveway slopes so vehicles can still utilize the driveways. Reconstruction should also be done in a manner to prevent further pooling of water and accumulation of debris within the accessible route of travel. The asphalt sidewalk at Ray Street (east side of North Main Street) should also be reclaimed and resurfaced.
